Stokke calls for voluntary product part replacement of Stokke Tripp Trapp Newborn Set

Stokke has announced a voluntary product part replacement due to an issue with the harness of the Tripp Trapp Newborn Set.

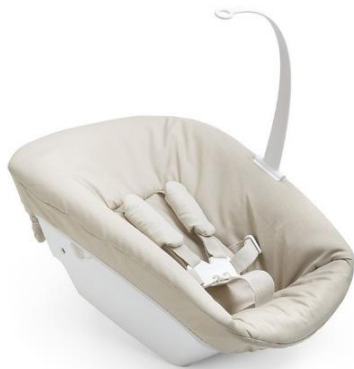
In some circumstances, the harness might be assembled incorrectly after washing or replacing it. A part of the harness could detach from the chair and pose a fall hazard for the child.

Affected sets are produced from October 2018.

To check if your product is affected and for more information on how you can get it replaced, visit reclamations.stokke.com/newbornupgrade.
