Shimano (Singapore) Pte. Ltd. Recalls Cranksets for Bicycles Due to Crash Hazard

Shimano has launched a voluntary inspection and replacement program for some bonded 11-speed HOLLOWTECH II road cranksets produced before July 2019 for a possible bonding separation issue, posing a crash hazard to consumers.

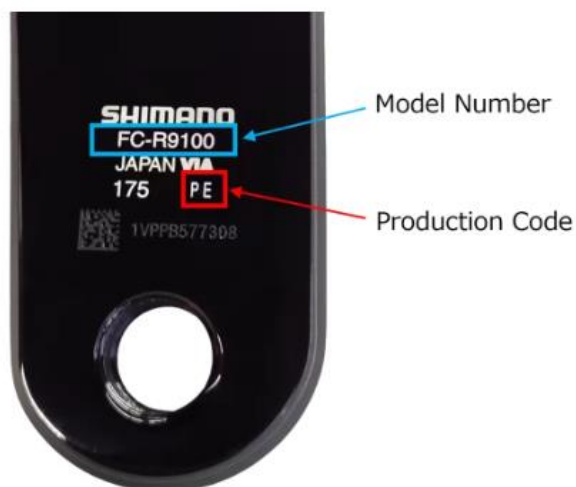
This recall involves models Ultegra FC-6800, Dura-Ace FC-9000, Ultegra FC-R8000, Dura-Ace FC-R9100 and FC-R9100P 11-Speed Bonded Hollowtech Road Cranksets manufactured prior to July 2019 sold individually and on bicycles sold by other manufacturers such as Trek and Specialized. A crankset is the component of the bicycle that the chain and pedals attach to for pedalling. The model numbers are stamped on the inside of the crank arm near the bottom of the arm. The affected models are pre-July 2019 production and have the following two-letter production code on the crank arm where the pedals are attached (red box on the image below): KF, KG, KH, KI, KJ, KK, KL, LA, LB, LC, LD, LE, LF, LG, LH, LI, LJ, LK, LL, MA, MB, MC, MD, ME, MF, MG, MH, MI, MJ, MK, ML, NA, NB, NC, ND, NE, NF, NG, NH, NI, NJ, NK, NL, OA, OB, OC, OD, OE, OF, OG, OH, OI, OJ, OK, OL, PA, PB, PC, PD, PE, PF, PG, PH, PI, PJ, PK, PL, QA, QB, QC, QD, QE, QF, QG, QH, QI, QJ, QK, QL, RA, RB, RC, RD, RE, and RF.

Consumers who owned the affected models of cranksets should immediately stop using them, and contact Shimano at +65 98305212 to schedule a free crankset inspection. Consumers whose cranksets show signs of bonding separation or delamination during the inspection will be provided a free replacement crankset and installation.
